Navajo Abandoned Uranium Mine

Site Screen Report

Swt003 AUM Site

Navajo AUM Northern Region

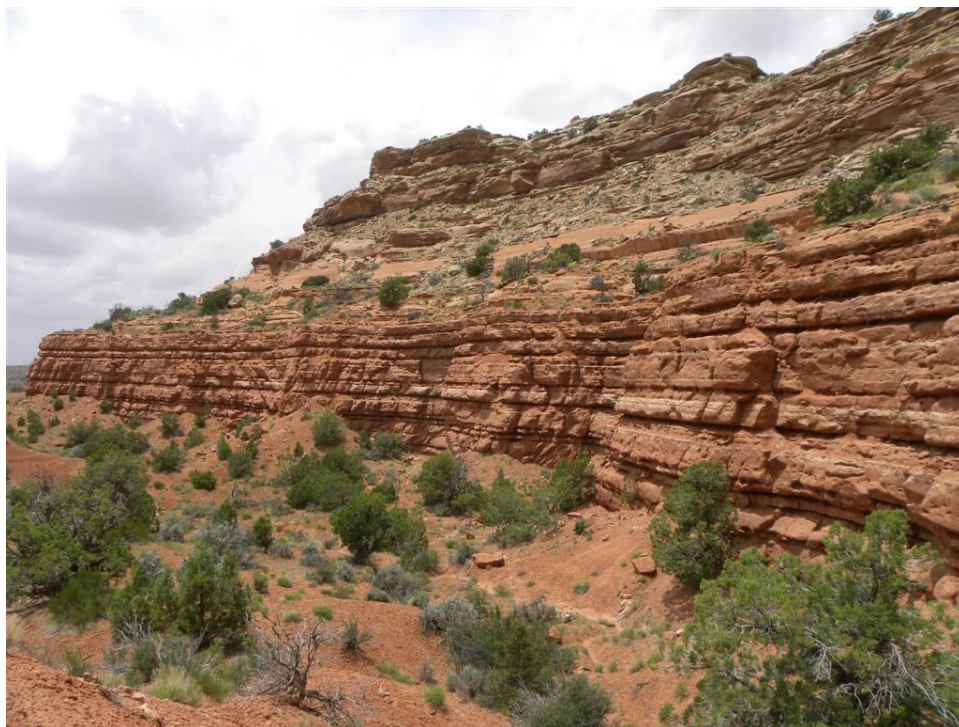
Photo 1. Swt003 site

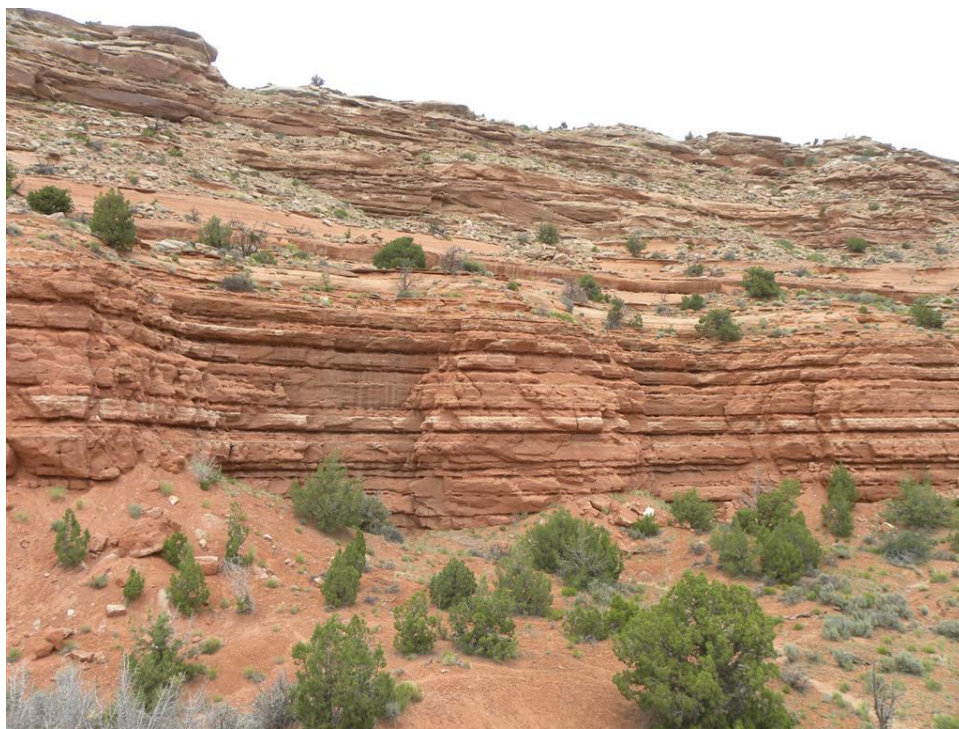
Photo 2. Swt003 site
